DISCHARGE MEASUREMENTS AND MAPS OF THE SAWMILL COVE SPRINGS
NEAR YAKUTAT, ALASKA

PREPARED FOR THE YAKUTAT REGIONAL AQUACULTURE ASSOCIATION
ALASKA HYDROSCIENCE, OCTOBER 2015.

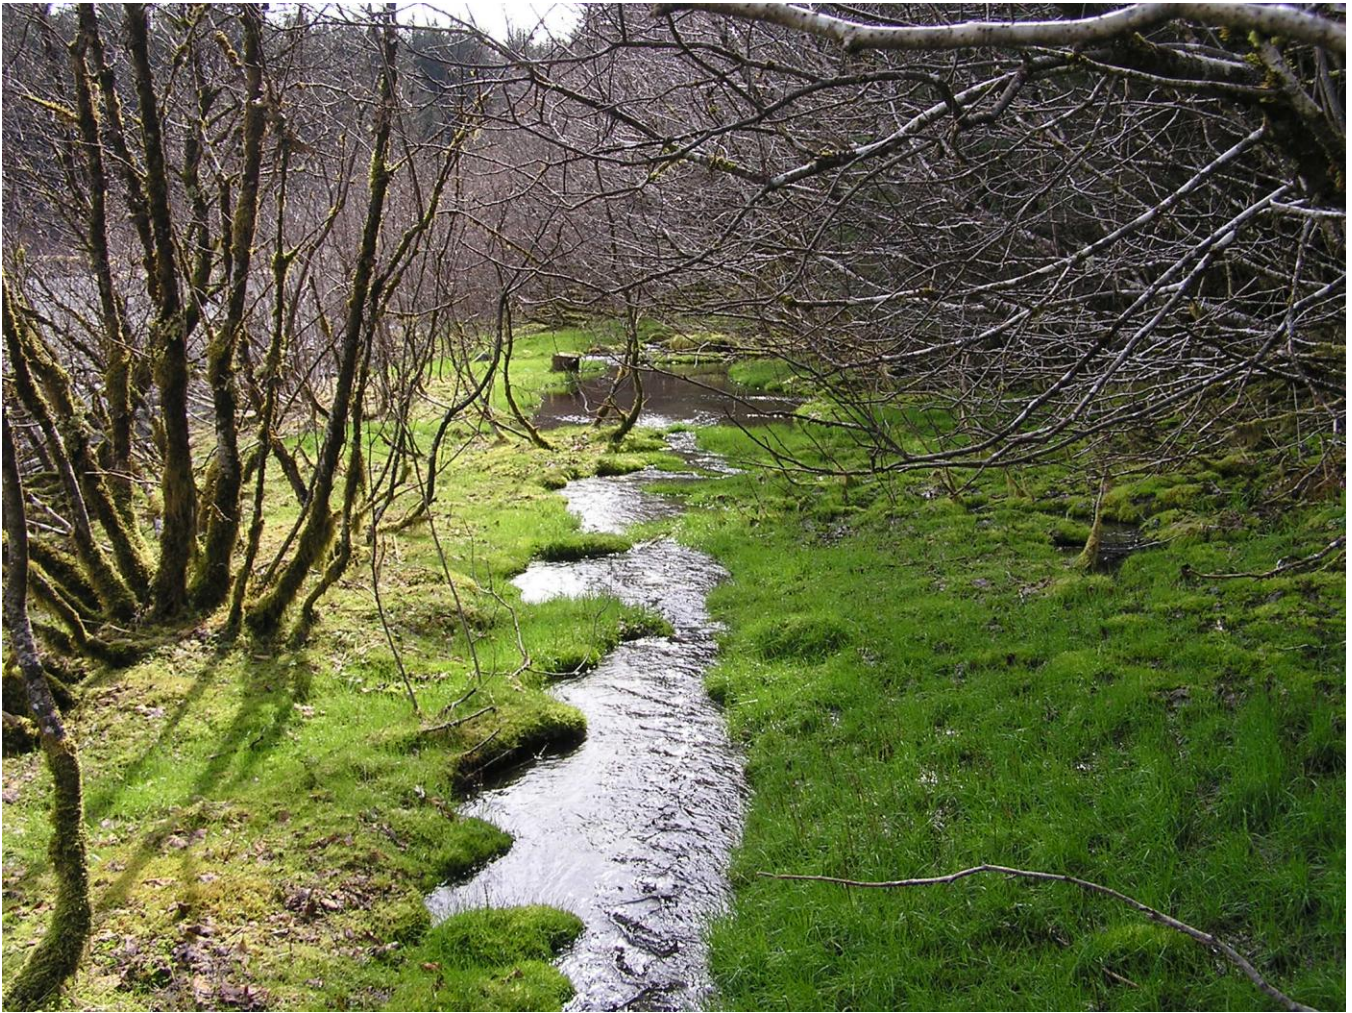
Spring A (figure 2) emerges from the ground approximately 140 feet north west of the measurement location at an elevation 8-10 feet above the beach terrace. It accumulates discharge from a series of tributary springs emerging from the hillside. On average, spring A accumulates the largest discharge contribution of the measured springs, with discharges ranging from 197 to 485 gpm (table 1). At high flows some spring discharge will not be measurable as flow overflows the confined channel both east and west of the measurement location.

Figure 3. Photo of spring A flowing east across the beach terrace upstream of the measurement location (discharge 485 gpm).

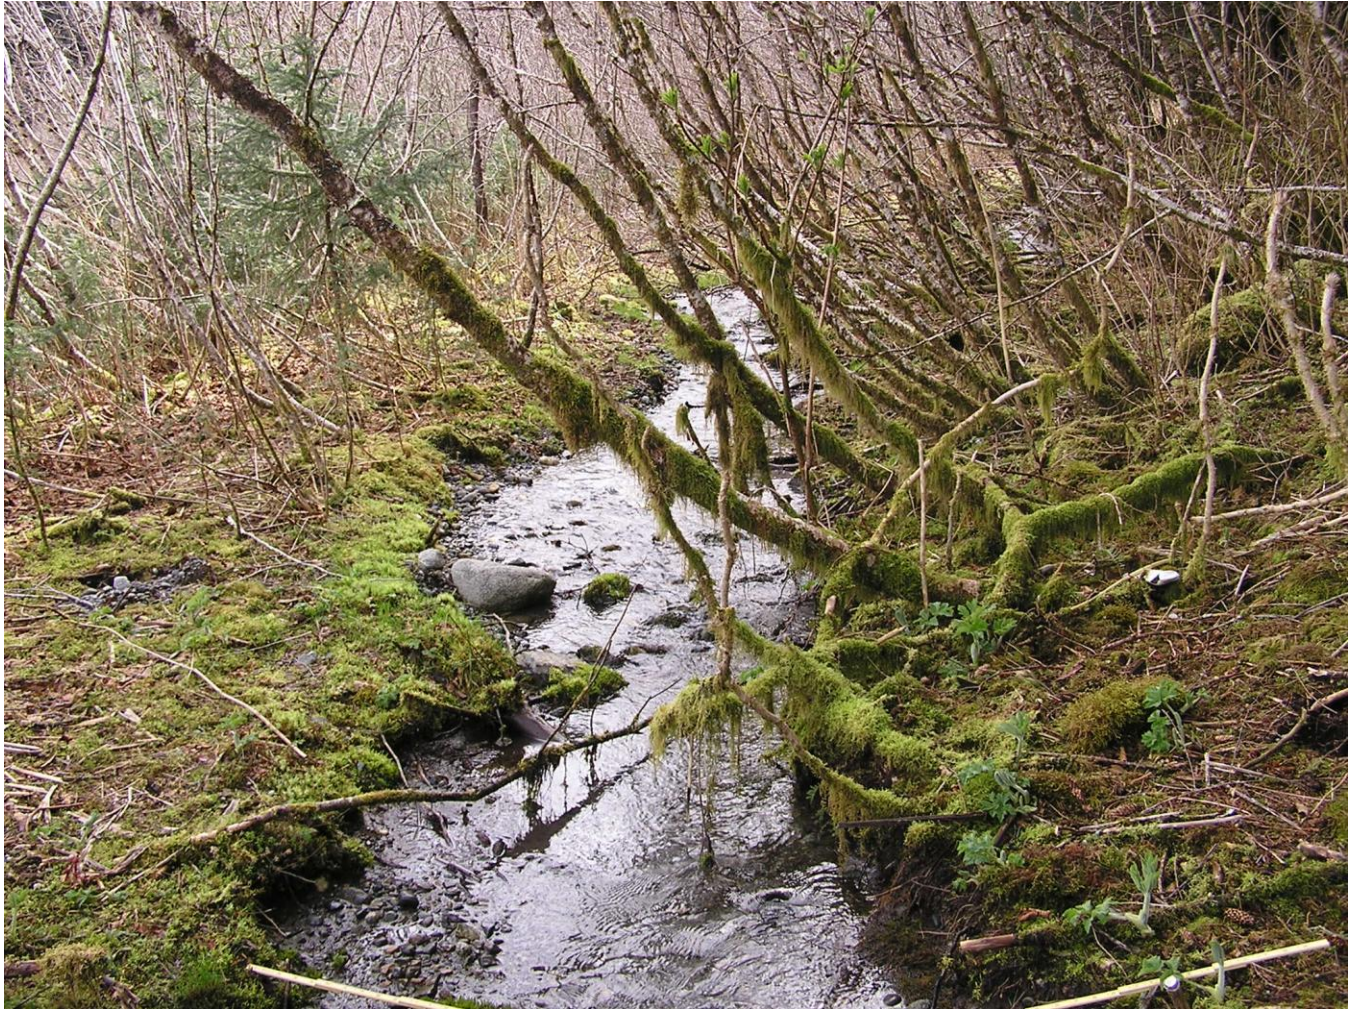
At the time of the survey spring B emerged from the hill side adjacent to the road approximately 300 feet upstream from the measurement location. It accumulated additional discharge from two small springs as it flowed toward the measurement location. Spring B discharges less water than the other measured springs and measured discharges have ranged from 13 to 211 gpm (table 1). Measurements of Spring B may include surface water runoff and associated sediment loading from the road during periods of high flow as the upstream reach flows through a ditch adjacent to the road.

Figure 4. Spring B at the measurement location just upstream of tide water (discharge 121 gpm).

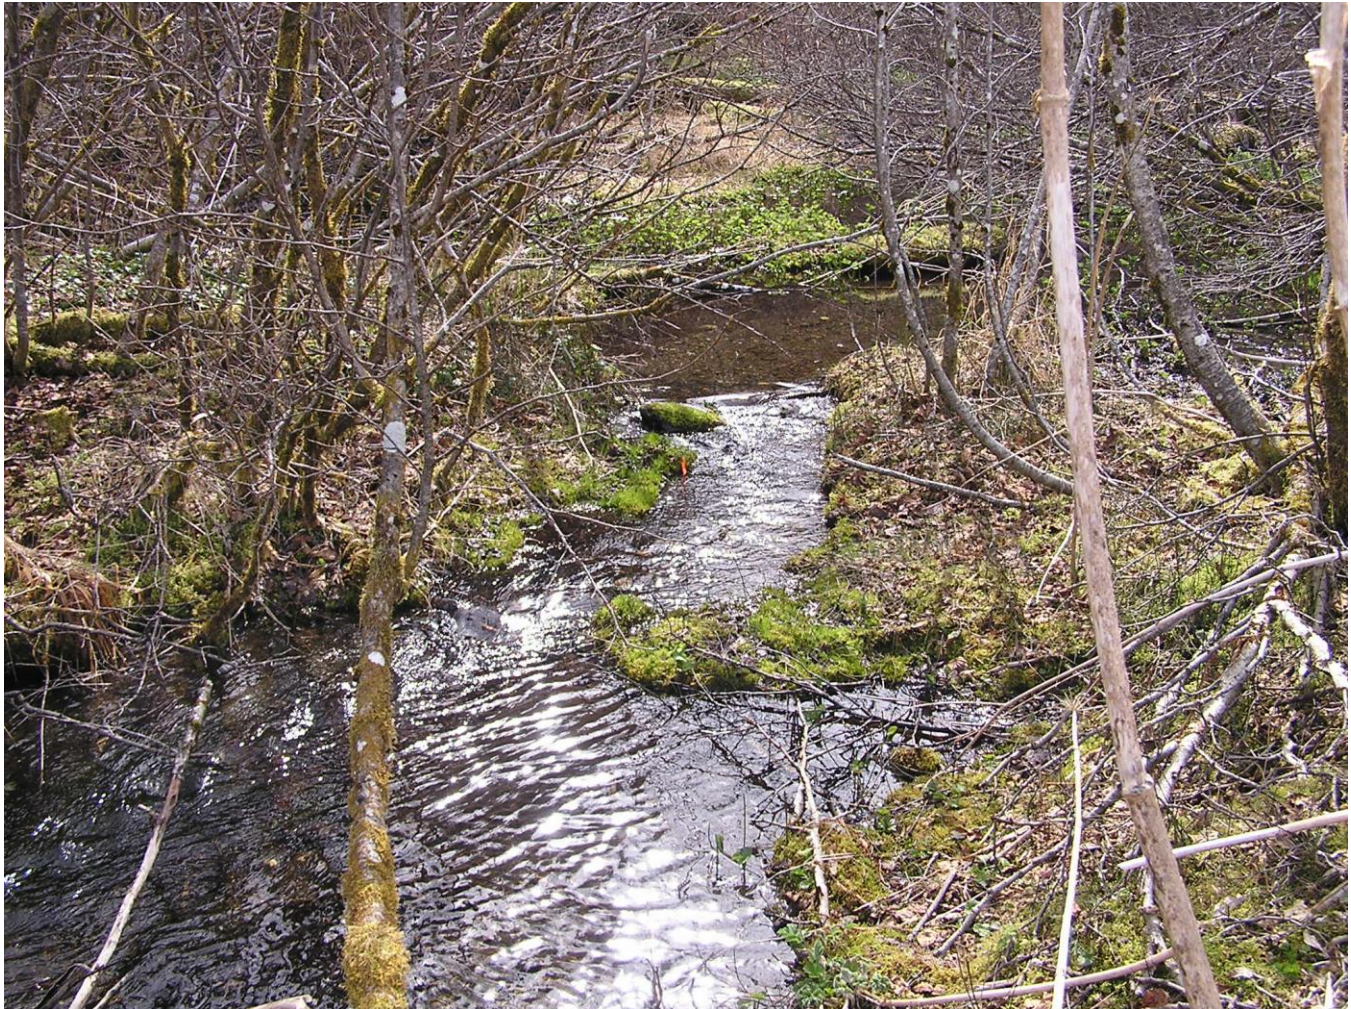
Spring C emerges from the hill side at several locations upstream from the measurement site and generally flows northward before all tributaries converge at the measurement site. The upstream extent of surface water discharge was found approximately 180 feet upstream of the measurement location. Discharges in Spring C have ranged from 72 to 305 gpm (table 1). Spring C contributes less discharge than all of the other measured springs with the exception of spring B.

Figure 5. Photograph of spring C taken at the discharge measurement location immediately upstream of the road (discharge 265 gpm).

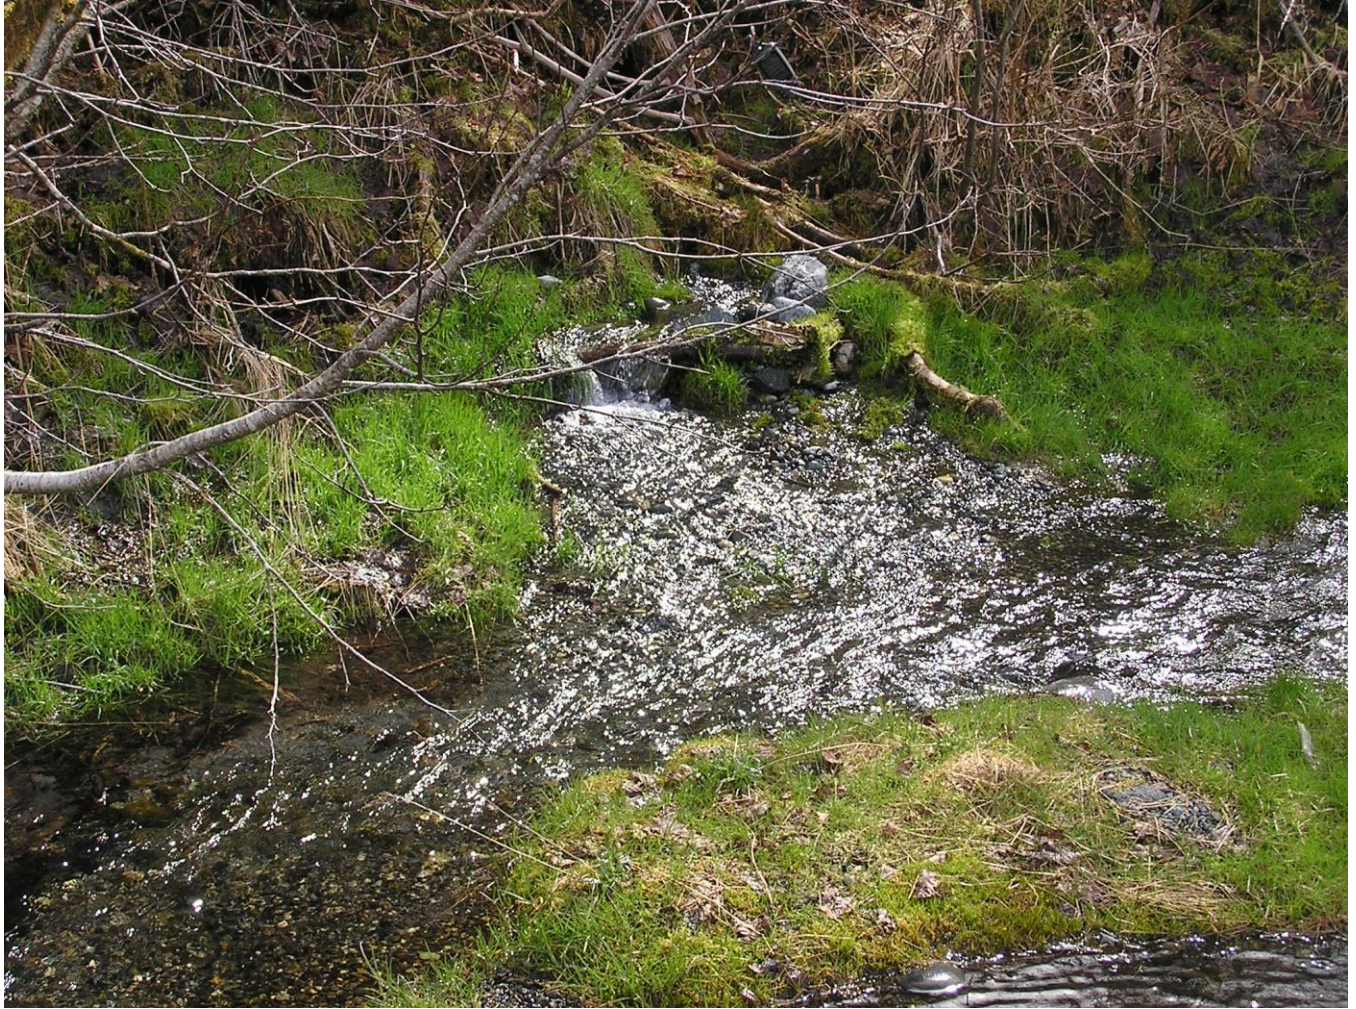
The upstream extent of spring D emerges from the hill side about 500 feet to the south west of the measurement location, which is immediately adjacent to the road. It flows east and north accumulating discharge from numerous springs emerging from the hillside including one large tributary spring that converges immediately above the measurement location. Discharges in spring D have been measured from 157 to 570 gpm. Despite having the largest measured flow volume (570 gpm) Spring D has the second greatest mean discharge of all the measured springs. Most of the springs contributing to spring D appear to emerge from the ground at an elevation approximately 20 feet above the road elevation.

Figure 6. Photograph of spring D at the measurement location (discharge 471 gpm).

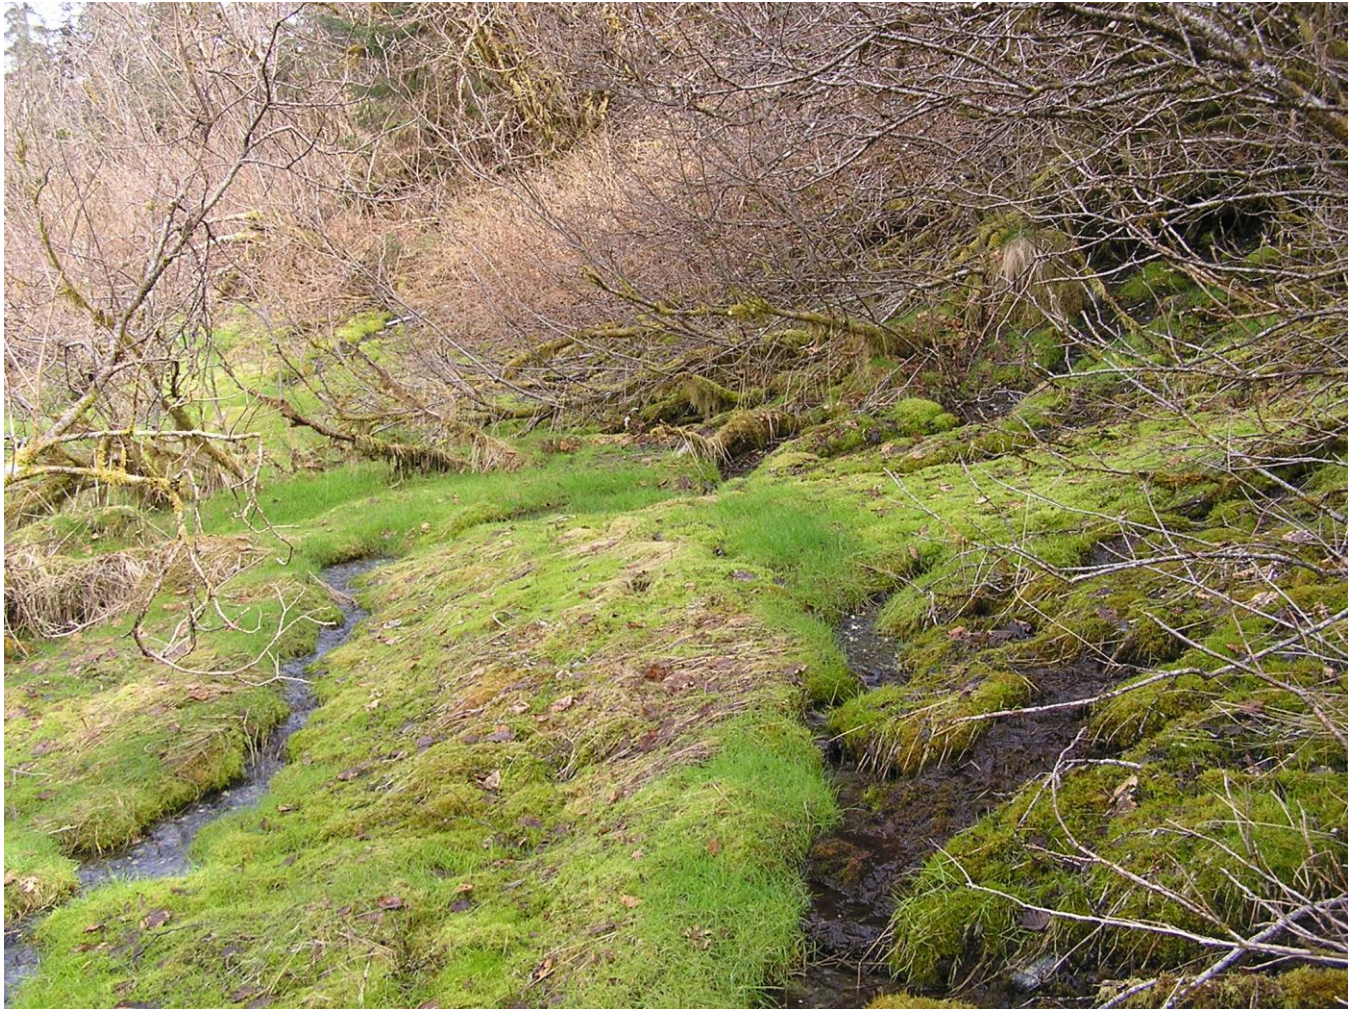
Figure 7. Tributary springs to Spring A emerging from the hillside upstream from the measurement location.

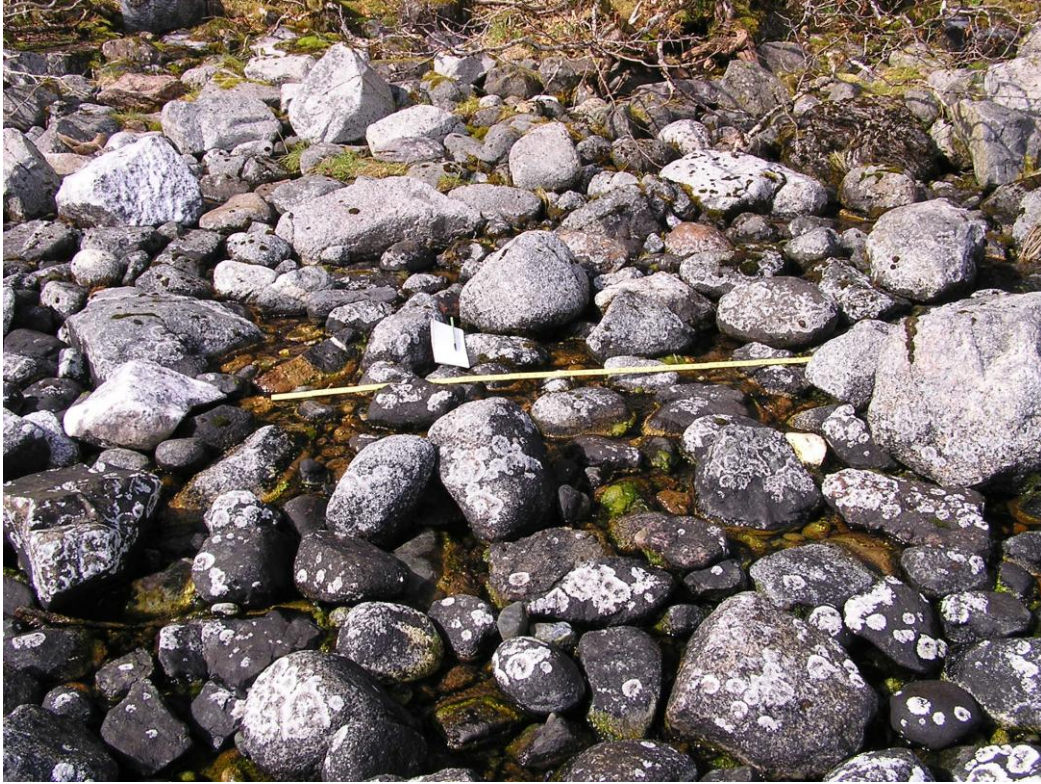
There were additional springs identified that did not converge into defined channels and could not be measured using conventional measurement equipment. Surface flow was visible in the springs located between springs A and B (figures 1 and 2) during all site visits, although this array of springs could not be measured I would estimate discharge from these springs nearly equivalent to discharge from spring C. Surface flow was also visible at the springs east of spring D during site visits. Springs to the north west of spring A were first identified during the February 2015 site visit and again when mapped in April of 2015 and both times appeared to provide a sizeable discharge relative to the measured springs. Collectively the discharge from the array of springs located to the north and west of spring A could equal or exceed the discharge of spring A. While the combined discharge of the unmeasured springs remains unknown it likely represents an important discharge component of your project if the discharge can be effectively utilized.

Figure 8. Northwest extent of unmeasured springs at Sawmill Cove showing a 5 foot ruler and note pad for scale.

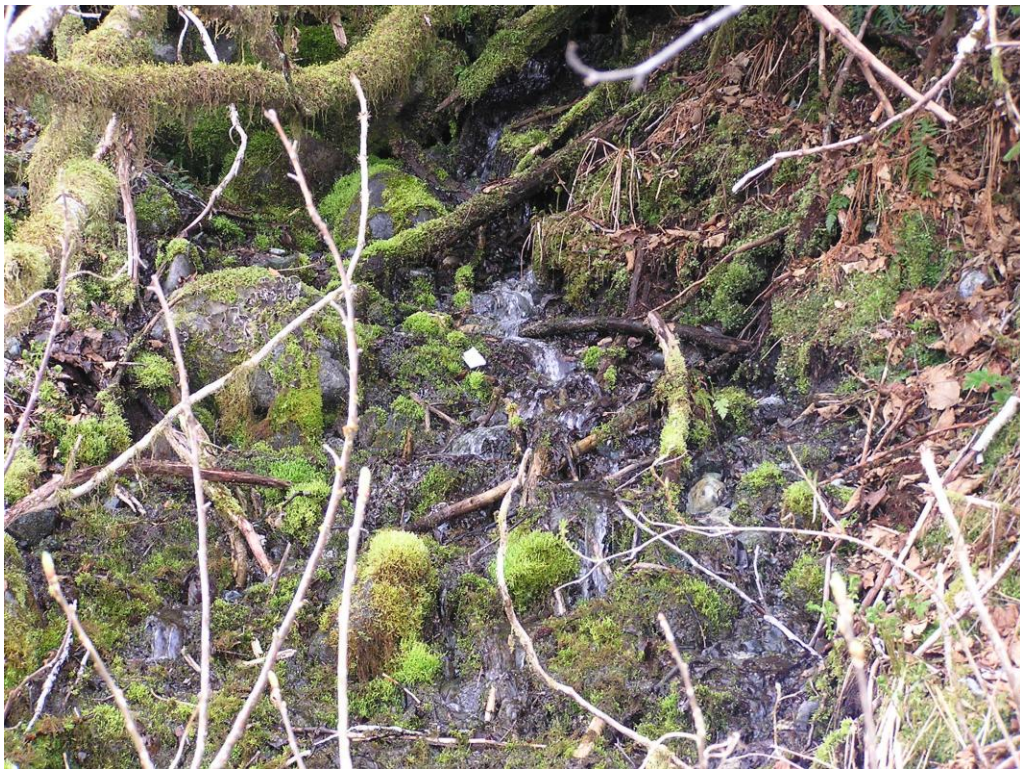
Figure 9. Spring emerging from hill slope between springs A and B.
