FIELD RECONNAISSANCE, GPS SURVEY AND DISCHARGE SIMULATIONS OF PUGET COVE PONDS NEAR YAKUTAT, ALASKA

PREPARED FOR THE YAKUTAT REGIONAL AQUACULTURE ASSOCIATION BY ALASKA HYDROSCIENCE, OCTOBER 2015.

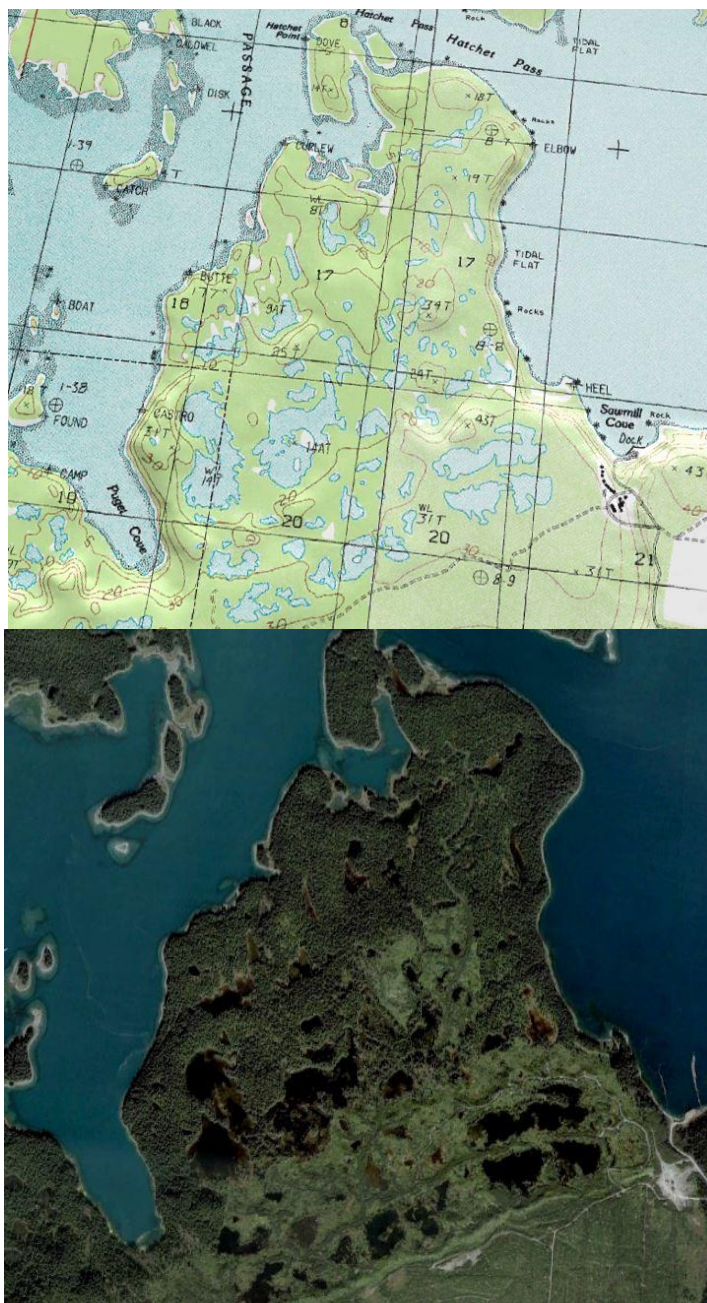
Figure 1 shows a map of the region surveyed. Track lines were generated with a Garmin GPSMAP 60CSx. As I traversed the watershed I made my best attempt at determining flow paths and drainage area delineations. Significant observations are noted below:

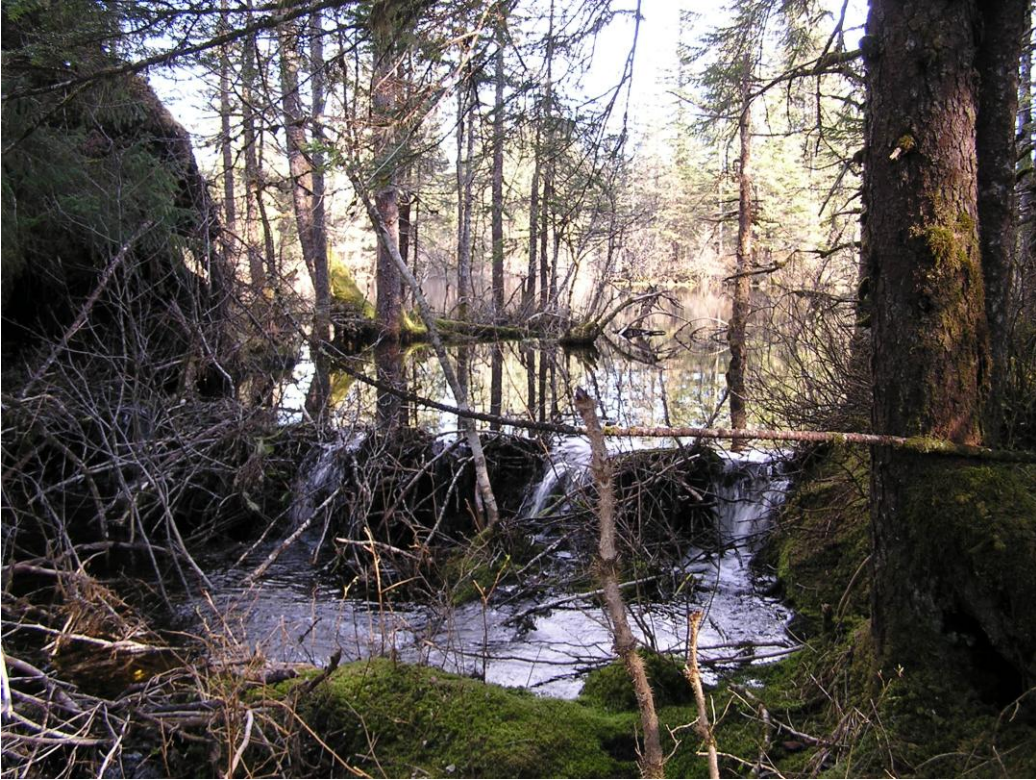
- Just downstream of the north outlet of the east pond, flow is constrained by a beaver dam approximately 30 feet wide and 3 feet high (figure 3). The current configuration of the pond outlet is likely an obstruction to anadromous fish passage at the observed discharge. This additional ponded water isn't visible in Google Earth imagery or displayed on USGS topographic maps.

Figure 3. Beaver dam located downstream of the north outlet of East Puget Cove Pond

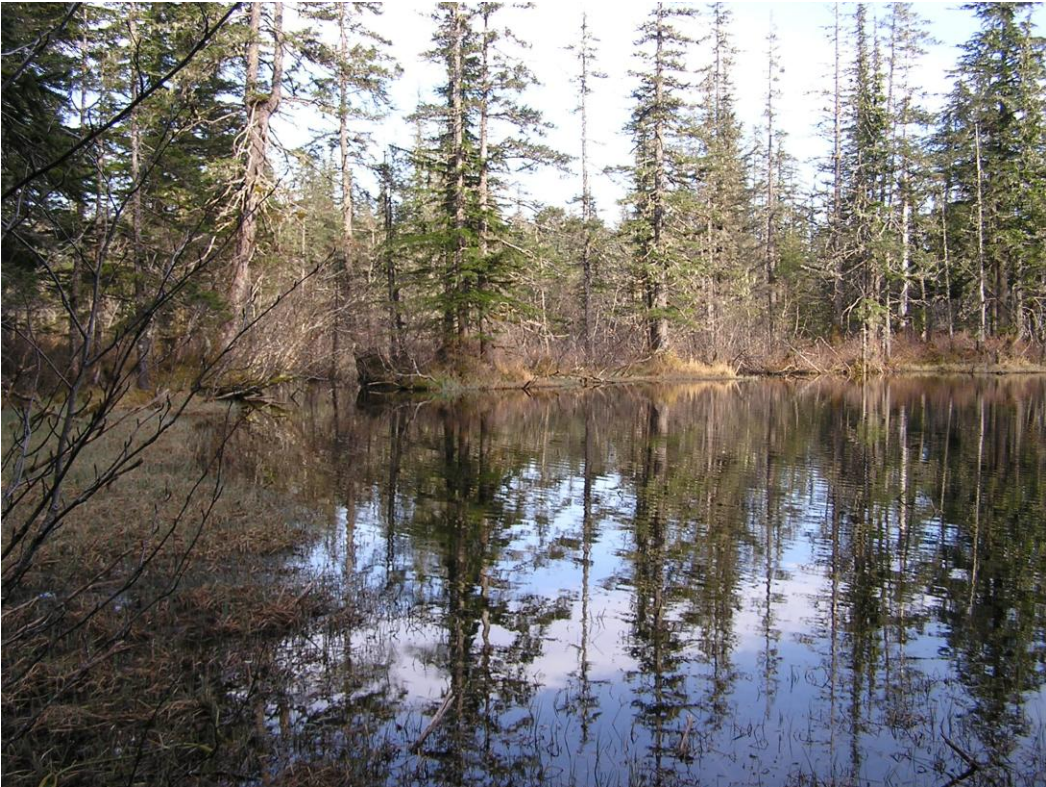
- The outlet of the east pond is in a region of low relief and it would be difficult to increase storage without considerable amounts of fill (figure 4).

Figure 4. Showing the north outlet of East Puget Cove Pond draining across a broad area of low relief.

The outlet of the east pond is in a broad area of low relief (figure 4) and increasing storage would likely require a significant effort in surveying, engineering, and earth moving in order to effectively increase water storage. Should you decide to conduct further feasibility inquiries into the Puget Cove Ponds as a viable water source for the project I would suggest installing a stream gage near the outlet of the east pond in order to determine actual discharges. Because the volume of water available from the watershed is clearly marginal, it is likely that gaging would be a requirement of the ADF&G permitting process.

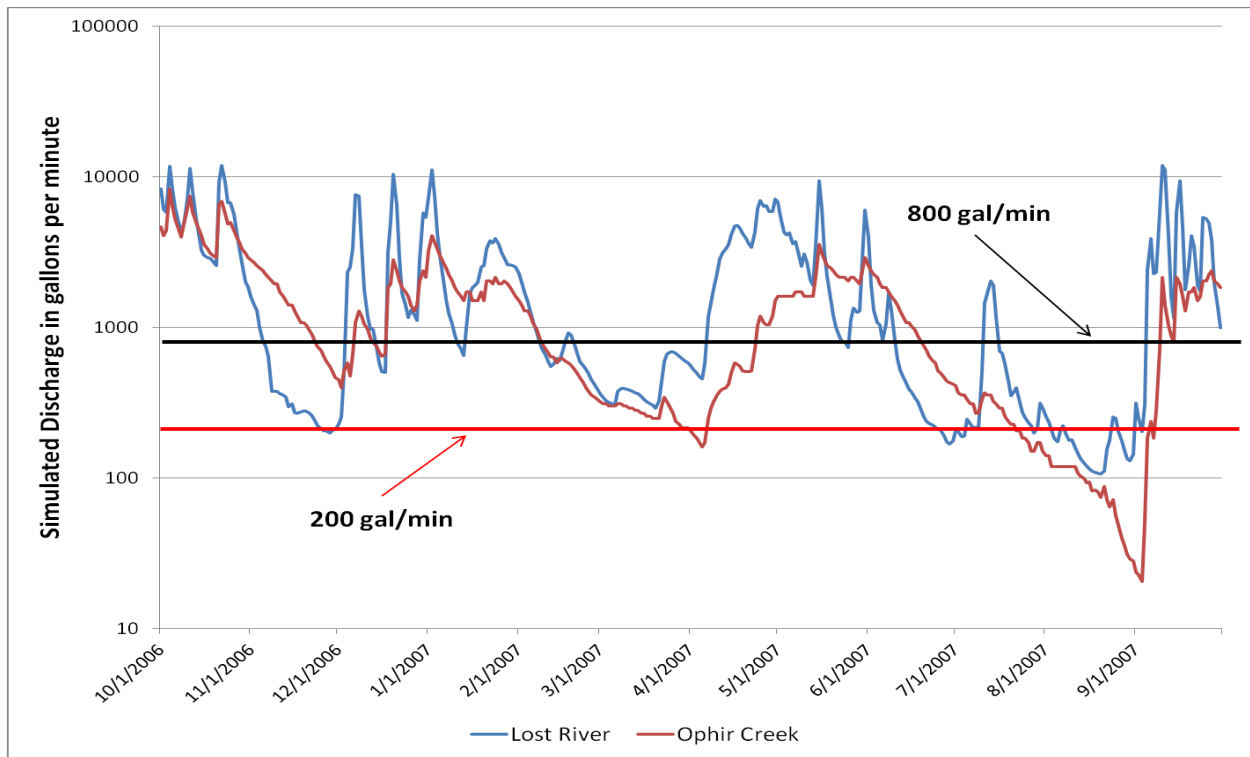
Figure 5. Daily mean discharge simulation of the Puget Cove Pond watershed area using hydrologic data from Ophir Creek (red) and the Lost River (blue) for the 2007 water year.

The reconnaissance survey suggests the watershed area of the ponds is considerably larger (0.6 vs. 0.25 mi²) than the estimate generated using topographic maps and satellite imagery alone. Despite the increase in estimated drainage area it is likely that this drainage still represents a marginal water source. To illustrate this I recomputed daily mean discharge simulations using daily mean discharges from Ophir Creek and the Lost River for the 2007 and 2011 water years (see Preliminary Hydrologic Assessment of Puget Cove Ponds for details in calculating simulations). Results are shown in figures 5 and 6. These simulations use the revised drainage area estimate of the ponds (0.60 mi²), and demonstrate discharge deficits at the 200 and 800 gpm levels despite the increase in estimated drainage area. Table 1 shows the number of days simulated discharges were below target discharges of 800, 400, and 200 gpm using flow simulations from Ophir Creek (USGS, 2015) and the Lost River for the 2007 and 2011 water years. These results suggest the need to draw from storage to obtain a continuous discharge of even 200 gpm. It is important to note that these simulations are meant to provide estimates. The storage function of the ponds could provide a discharge hydrograph with more or less volume and variability than the simulations.

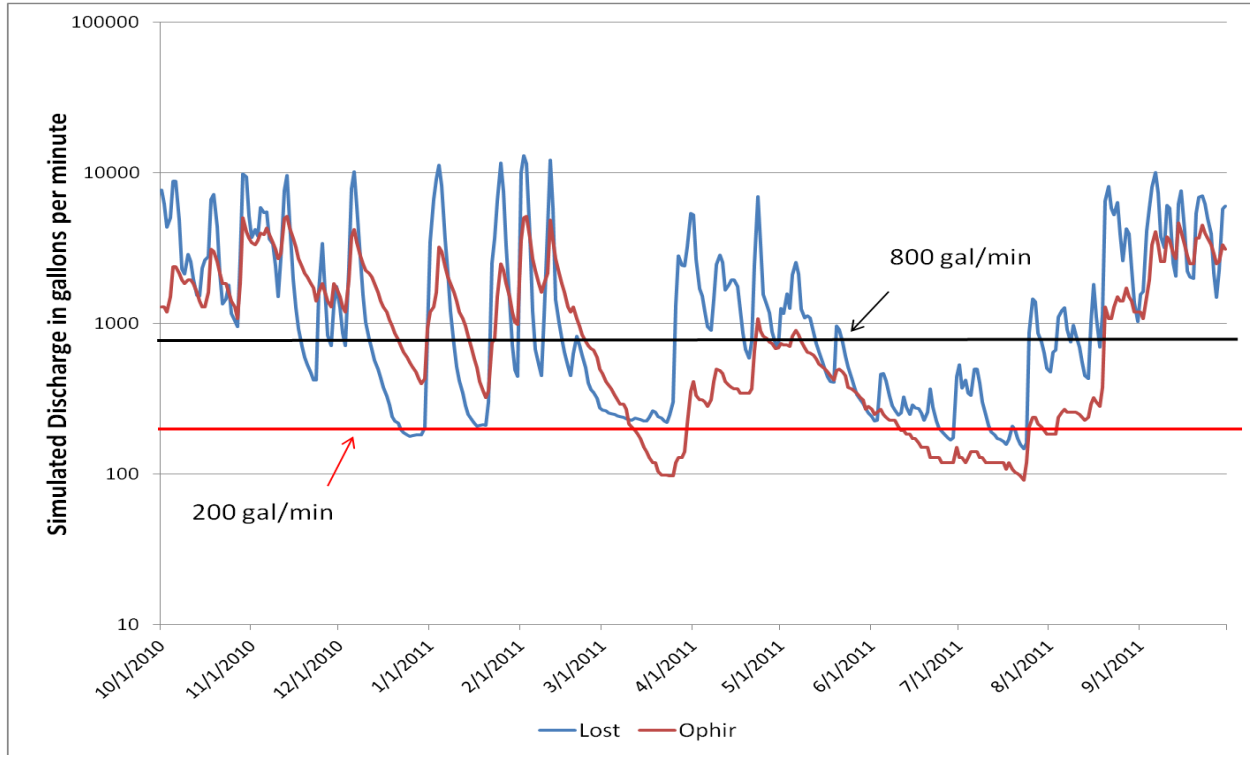
Figure 6. Daily mean discharge simulation of the Puget Cove Pond watershed area using hydrologic data from Ophir Creek (red) and the Lost River (blue) for the 2011 water year.
